November 1982

DMS-DR-2509
NASA-CR -167,654

SPACE SHUTTLE FRCI-12 TPS TILE VENTING
TEST IN THE NASA/AMES
RESEARCH CENTER 11x11-FOOT AND
9x7-FOOT WIND TUNNELS (OA307A/B)

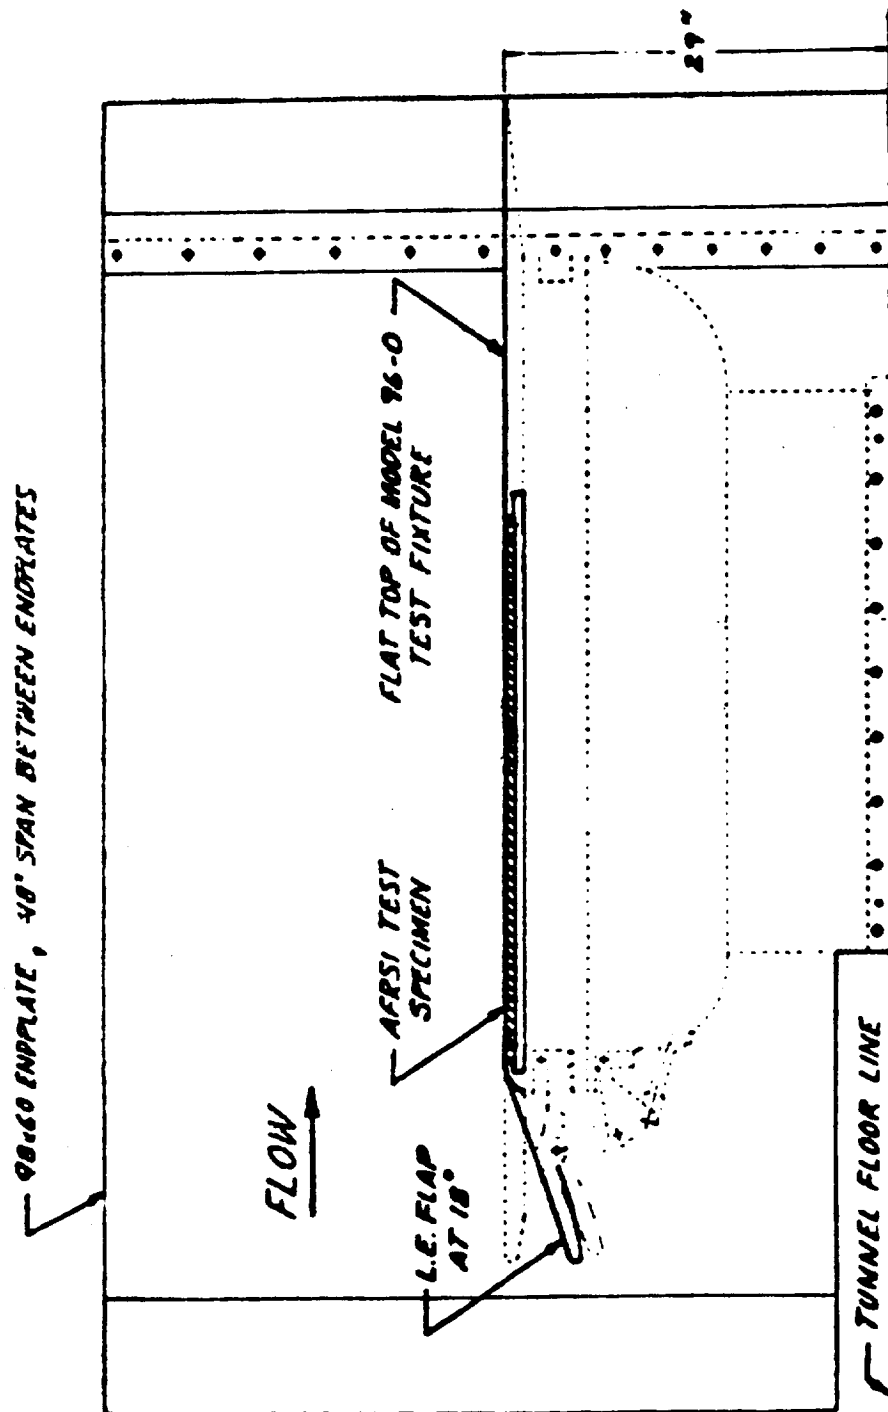
a. Fixture 96-0

The 96-0 fixture was used for test OA307A in the 11-foot wind tunnel. The fixture, depicted in Figure 1a, functioned to cause an expansion shock pattern ahead of the specimen, followed by a recompression shock region with attendant positive pressure gradients and high turbulence levels over the test specimen.

The mechanism employed to produce the desired expansion/recompression shocks was a 48-inch span, 15-inch chord flap located at the leading edge of the fixture. The flap was capable of being rotated through angles of zero to 30 degrees by a remotely controlled hydraulic actuator. However, for OA307A, the flap was set at an 18° incidence angle (L.E. down) and was left constant throughout the test.

The fixture was equipped with side plates to make the flow field two-dimensional in the test area. The plates extended from a height of 30 inches above the top of the test panel to 29 inches below the test panel, and were supported from underneath. The beveled leading edges were located 26 inches forward of the test specimen leading edge.

In each fixture, the test article was installed using the necessary spacer and shims, with ANF 5/16-24 and ANC 1/4-20 socket-head cap screws 6.25 inches long. The completed installation placed the leading edge of the test article flush within the test fixture. Figures 1a and 1b show the two installations.

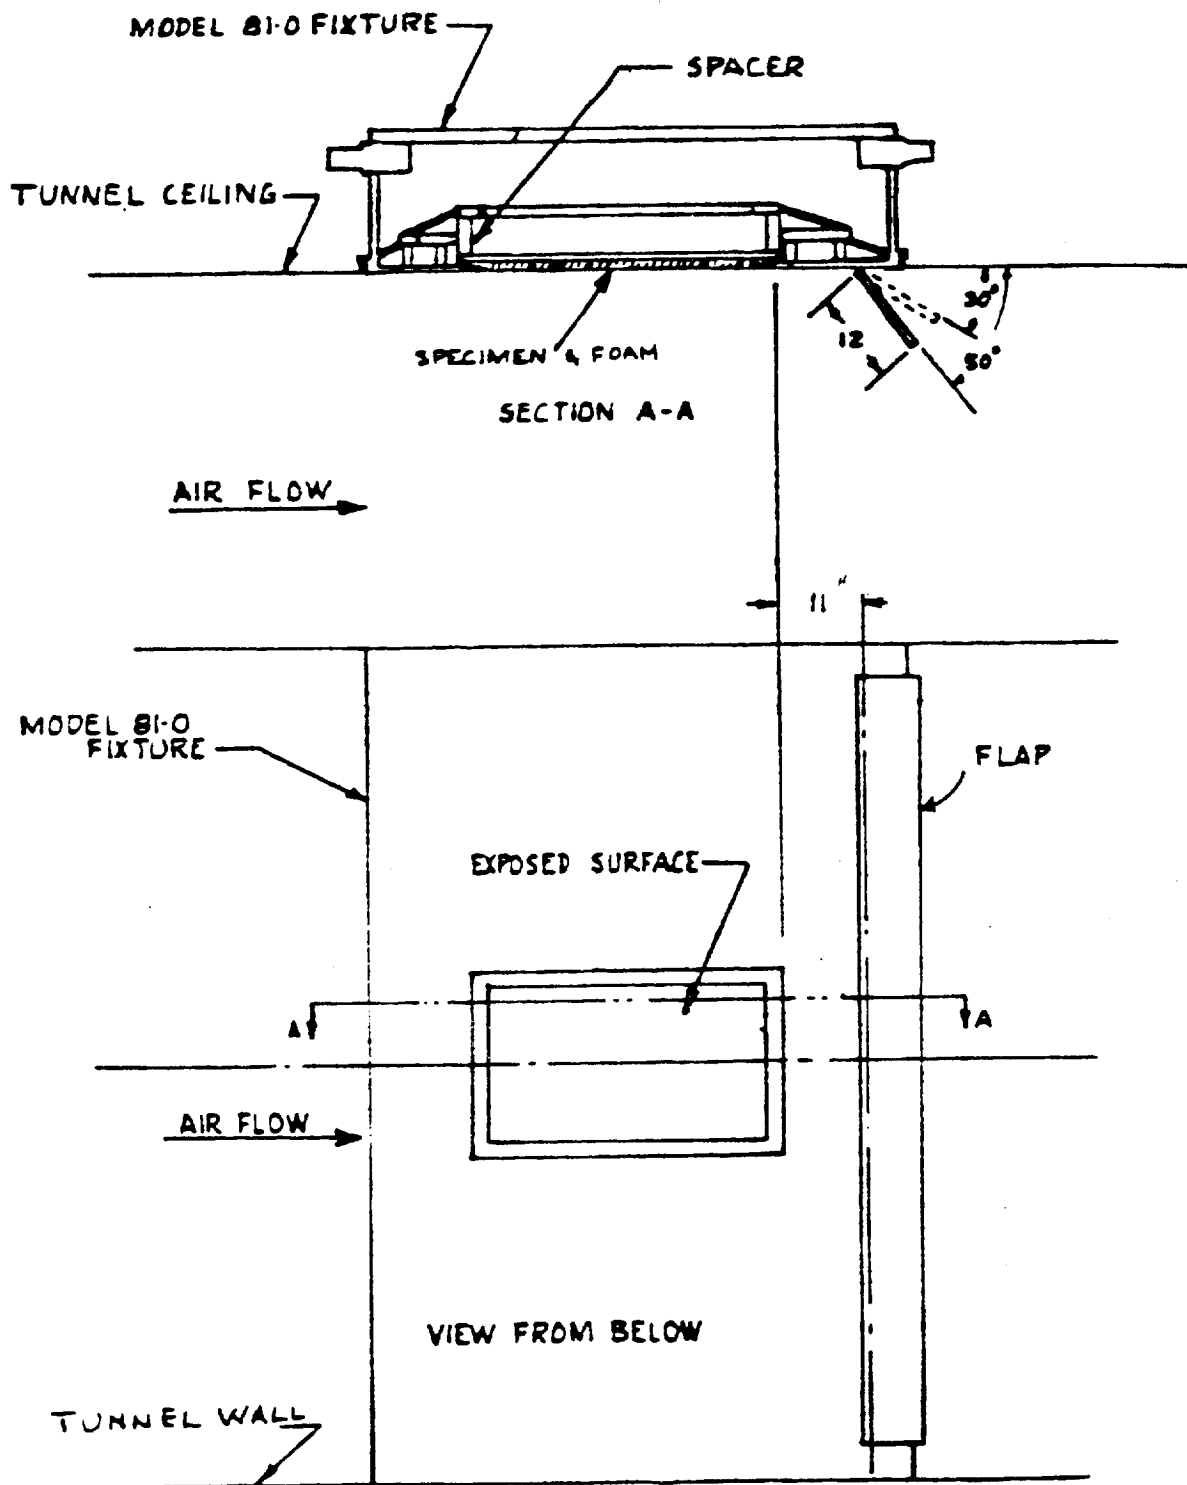
b. Fixture 81-0

This fixture, shown schematically in figure 1B, functioned to create a reverse flow region near the boundaries in the flap/surface corner, and the boundary layer separation, together with an unsteady shock wave over the specimen. The flow phenomenon gave rise to large step-type pressure gradients and high turbulence levels.

The fixture was mounted in the ceiling of the tunnel. The flow conditions over the test area were produced by deflecting a 12-inch chord flap with a 100-inch span, located aft of the FRCI-12 test panel. The flap, hinged on the ceiling, could be rotated from zero to 90 degrees by a remotely controlled hydraulic actuator. Test angles included settings from 0° to 55° .

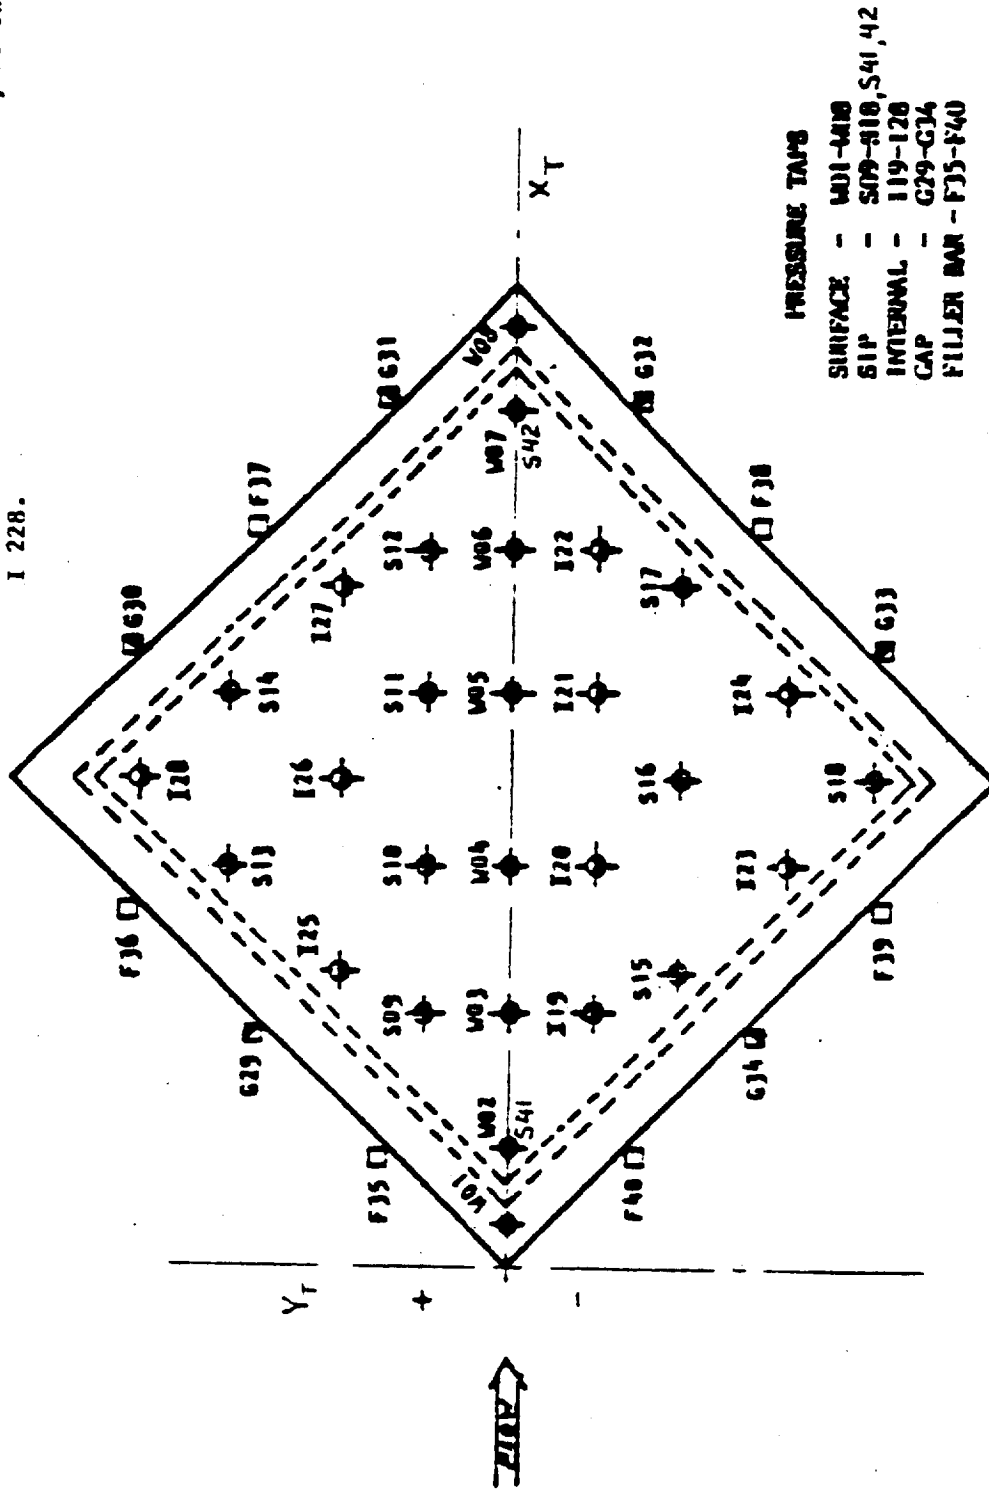
d. PRESSURE TAP LOCATION IN AND UNDER PRCI-12 TILE

Tiles numbered 41 and 48 have this pressure tap arrangement. Taps on Tile 41 have the added numeral 1, as in I 128, and taps in Tile 48 have the added numeral 2, as in I 228.

Special fabrication techniques were used to instrument and install the two FRCI-12 instrumented tiles on the panel. A hole was bored through both silica tiles 65 and 46 and the aluminum baseplate, which allowed the adjacent FRCI-12 tile pressure tubes to be routed across the tile gap, through a channel routed on top of the silica tiles and then downward through the hole in the tiles and baseplate. Clearance between tubes and tiles was maintained to allow freedom of tile motion on the SIP. A thin aluminum plate (6 in. by 6 in.) was then bonded to the top of silica tiles 65 and 46 to cover the hole and match the surrounding tile OML. Both FRCI-12 instrumented tiles had a 1/8-in. surface coating of RTV which embedded 8 surface static pressure tubes and also formed the new tile OML.

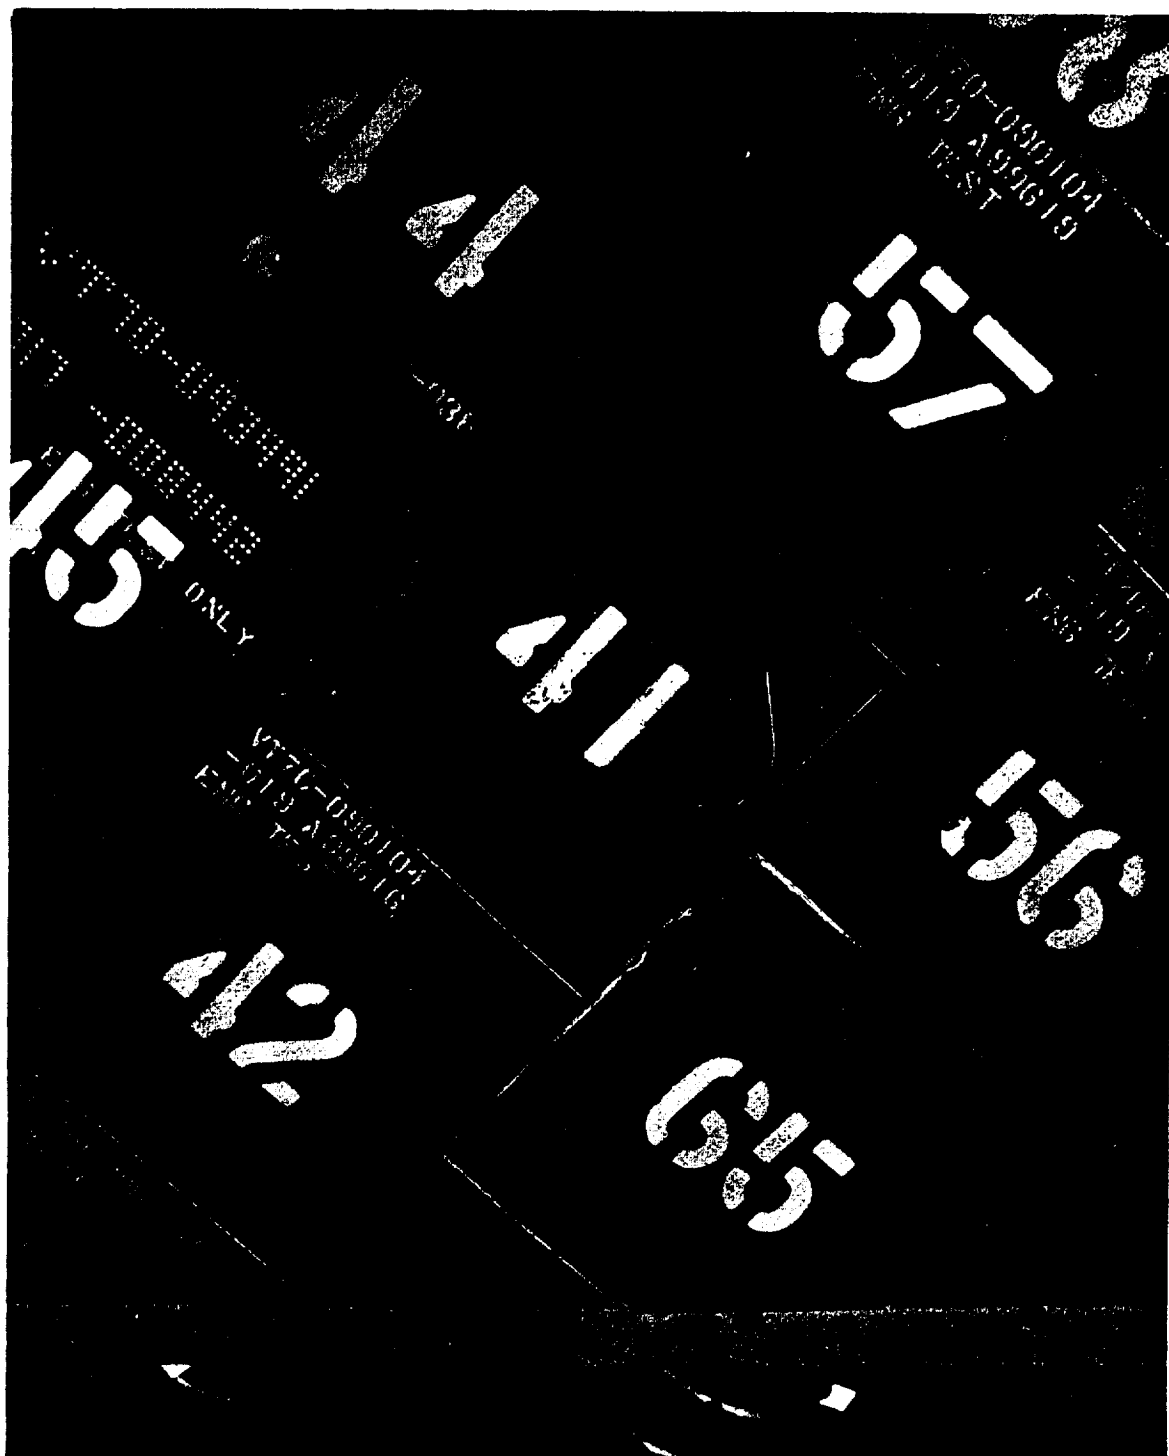
a. Damaged Instrumented Tile #41

All test objectives were met in spite of a failure on the forward FRCI-12 instrumented tile during OA307A in the 11x11-foot tunnel. A portion of the RTV surface layer on this tile debonded and broke off, thus exposing two of the eight pressure tubes being used to measure surface static pressure. Before the damage occurred, data were obtained at Mach 0.78 and 0.80 for the "B" priority runs at a tunnel P_t of 28 inches of mercury. Also, the leading edge of silica tile #56 lifted, causing a 1/4-inch SIP extension.

The other tiles in the array are denoted by S for silica and F for foam. During OA307A the test panel was damaged and a photograph depicting the damage is shown in Figure 2a.

With the tunnel total pressure constant at 22 inches of mercury, data were taken at each 0.02 Mach number increment up through 0.88, and then at each Mach number increment down to 0.78. The tunnel total pressure was then changed to 28 inches of mercury and data were taken at Mach 0.78 and 0.80. This Mach number sweep was not completed and the tunnel was shut down (fast stop) because the panel was damaged as observed on the video screen.

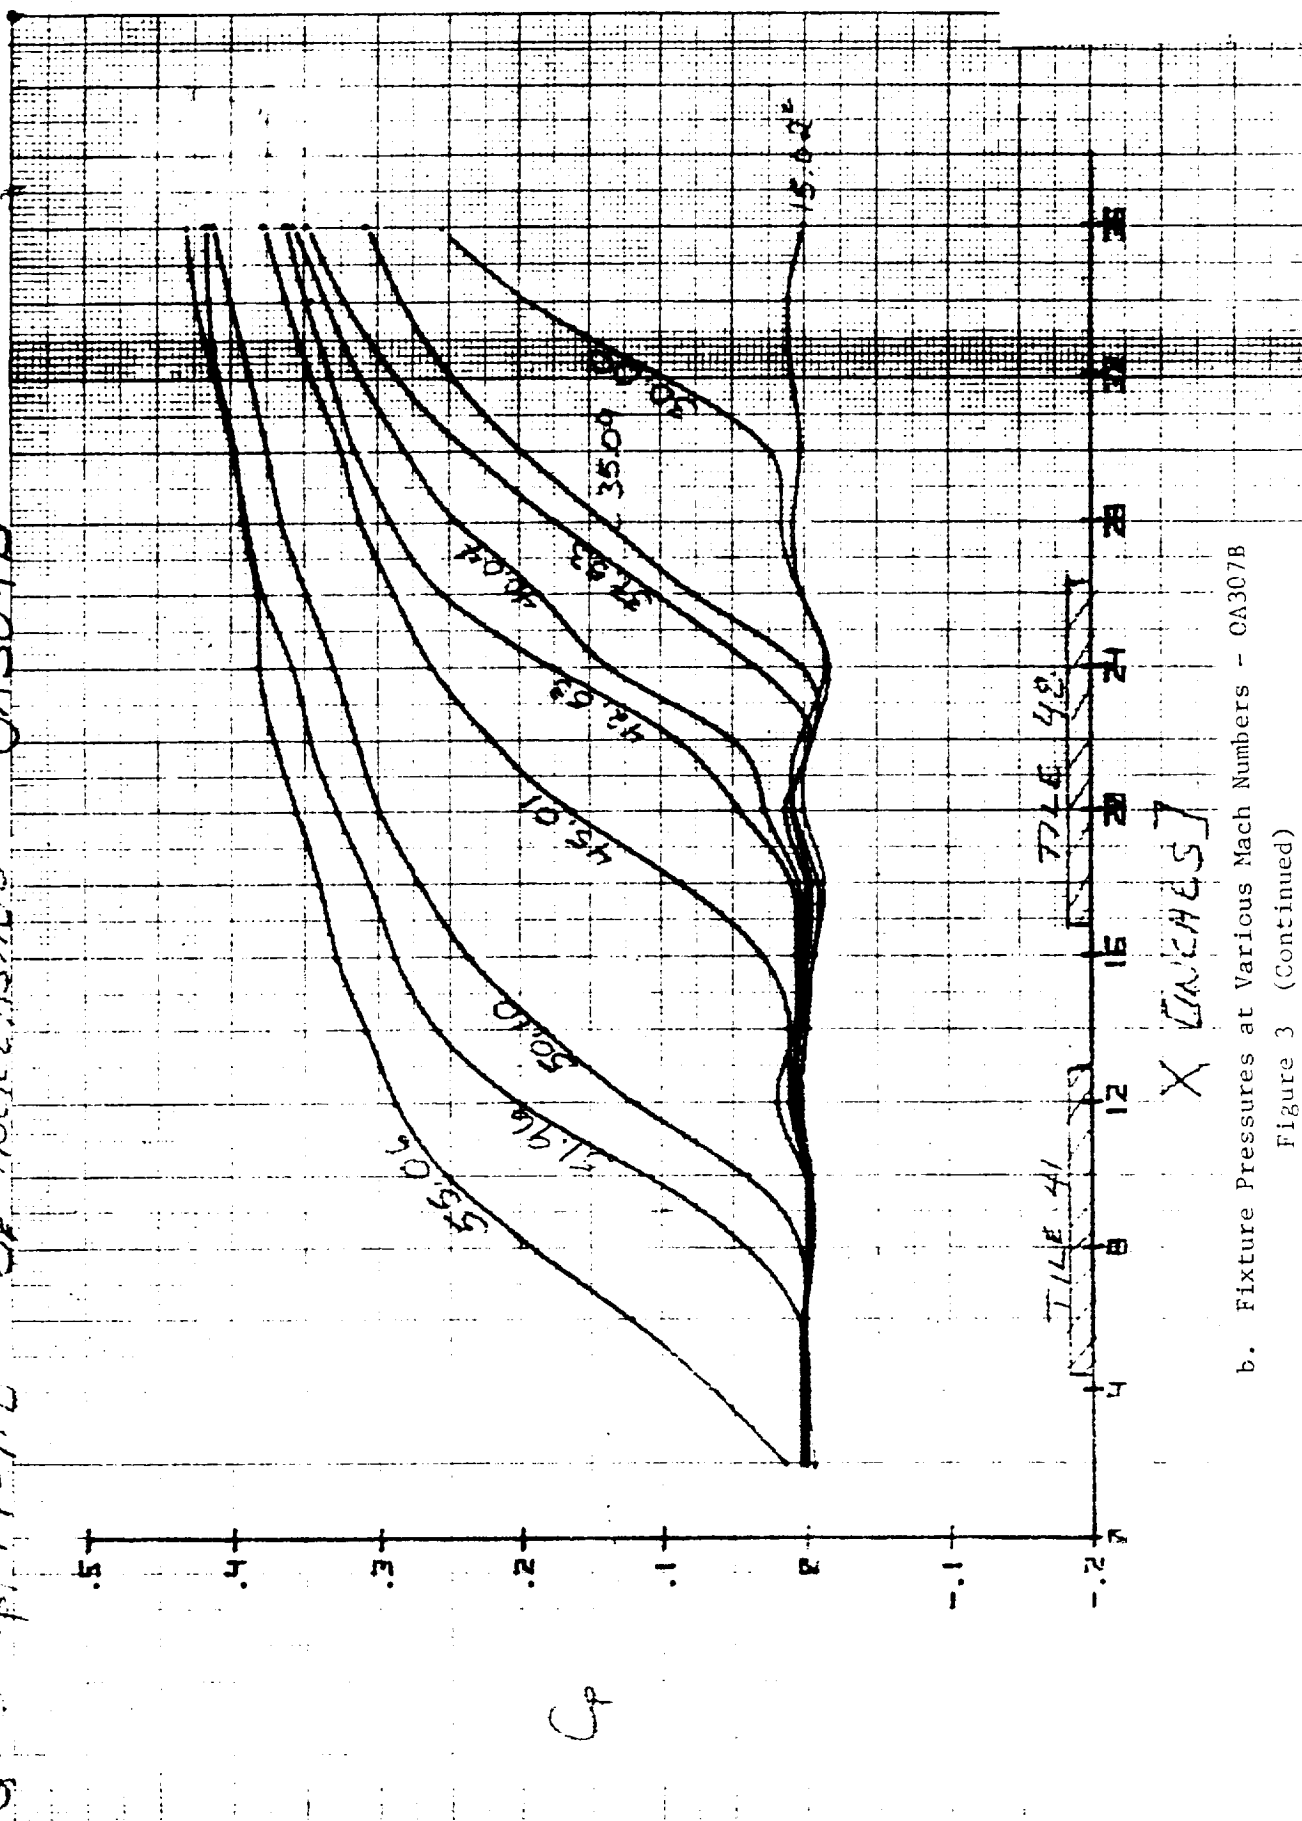
b. Fixture Pressures at Various Mach Numbers - OA307B

Q: 8000 ft M=1.8 S_F INCREASING OA307B

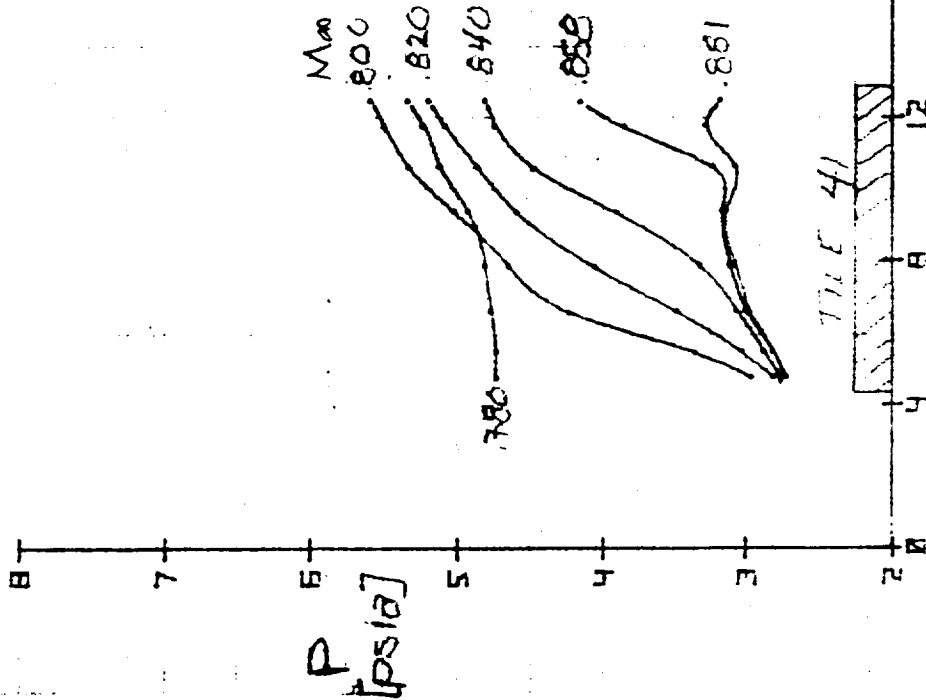
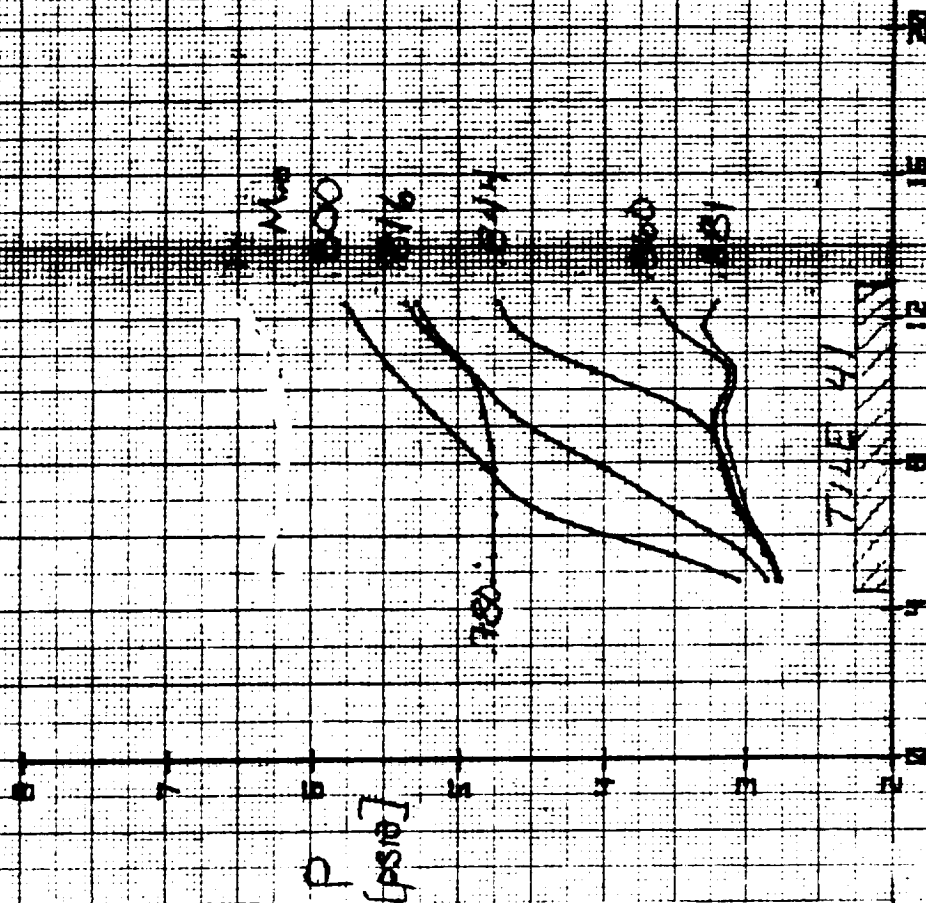
c. Tile Surface Pressures at Various Mach Numbers - OA307A

OA307A
INCREASING MACH NUMBER

$$\delta_{FLAP} = 18^\circ$$

DECREASING MACH NUMBER

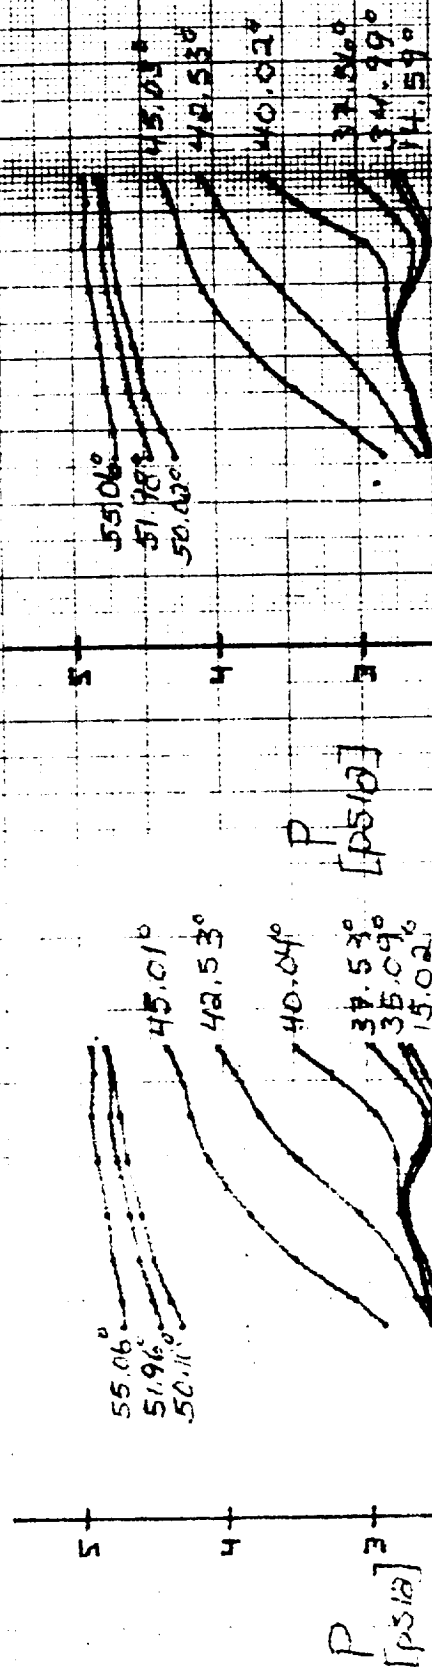
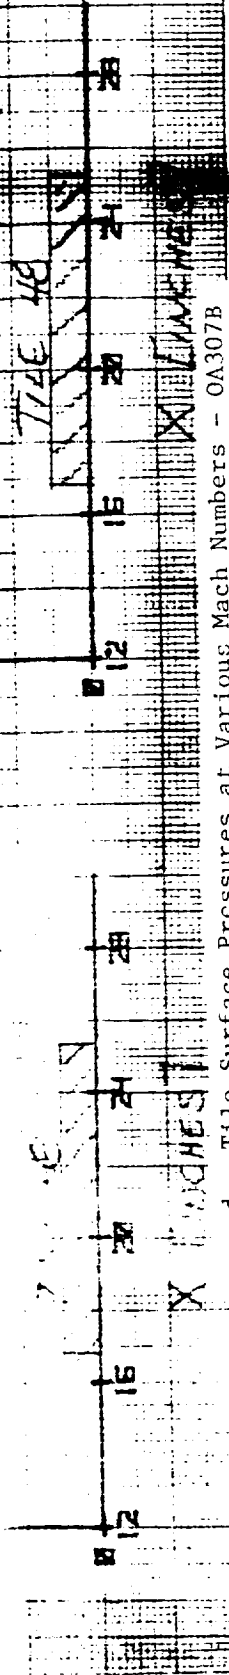
d. Tile Surface Pressures at Various Mach Numbers - OA307B

Q = 860 psf

M = 1.8

FLAP ANGLE DECREASING

FLAP ANGLE INCREASING

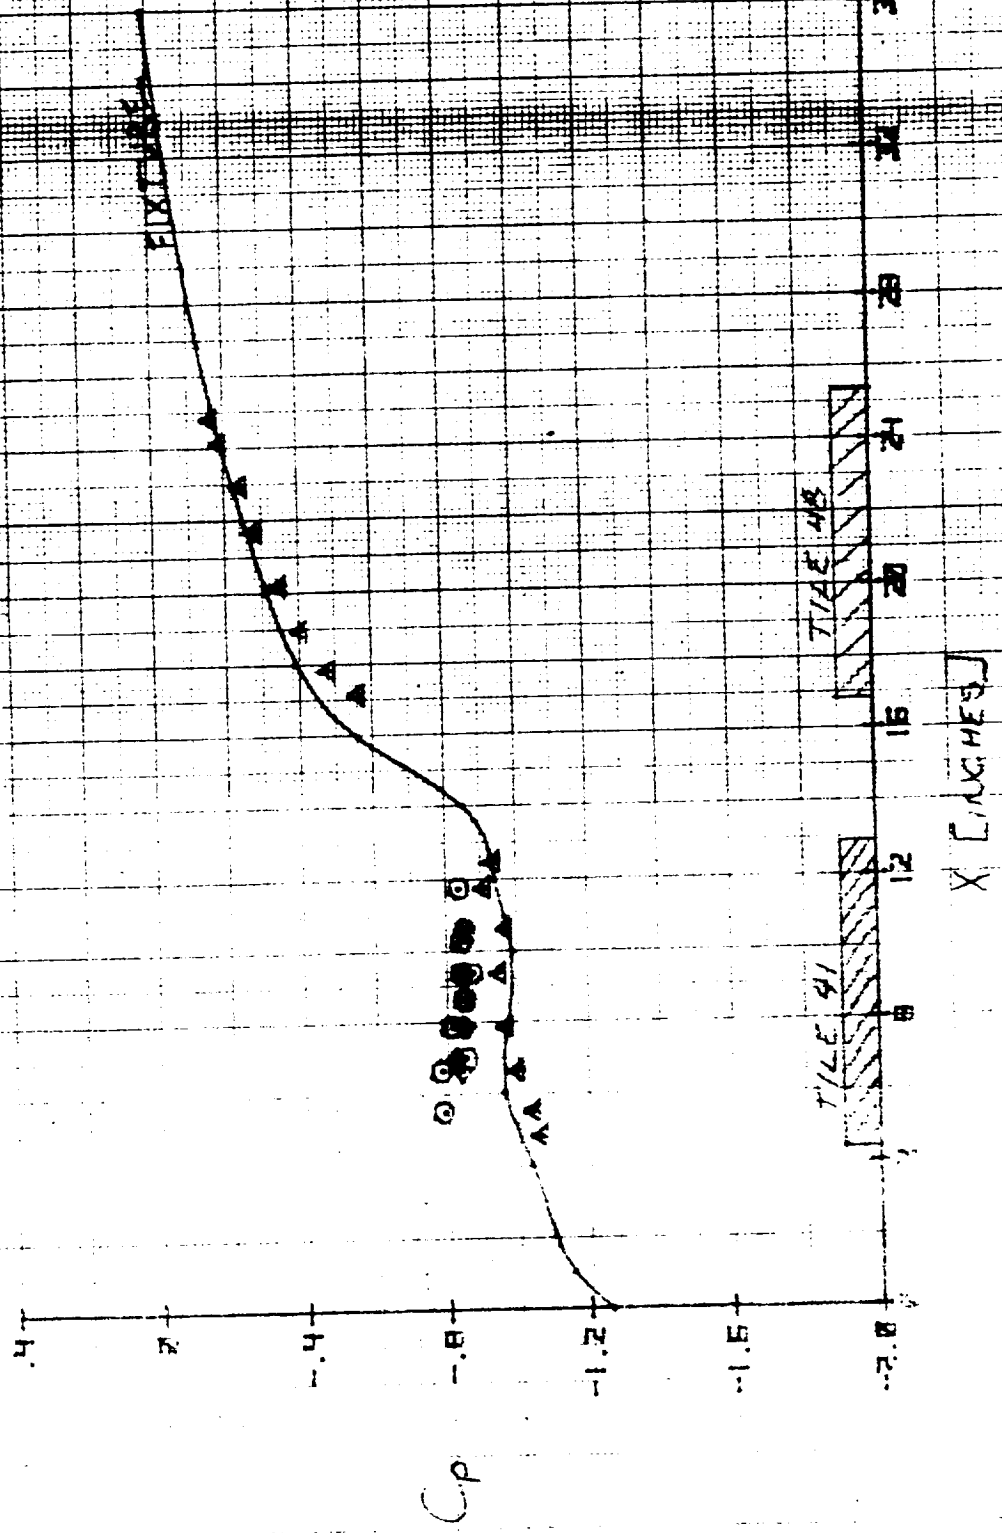
f. Fixture, Tile Surface, Internal and SIP Pressures at $M = .881 - OA307A$
 Figure 3 (Continued)

△ SURFACE
 ○ INTERNAL
 ○ SIP

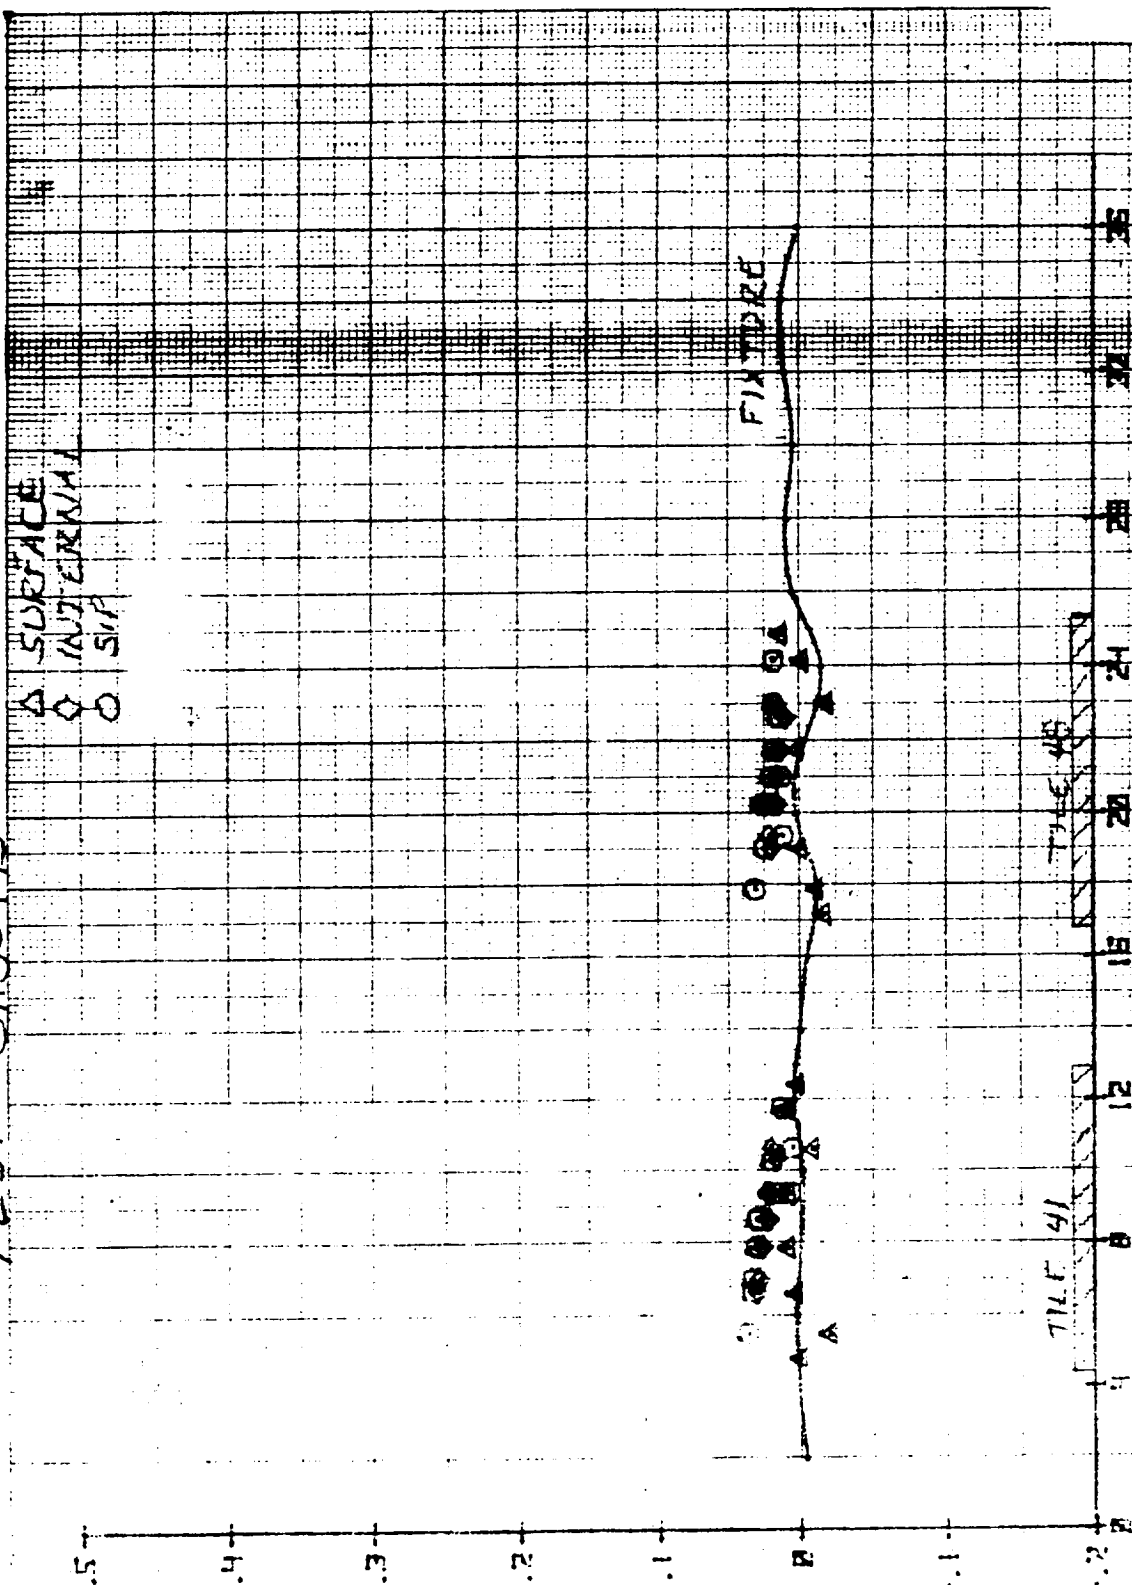
g. Fixture, Tile Surface, Internal and SIP Pressures at $M = 1.8, \delta_f = 15.02^\circ$ - OA307B

△ SURFACE
○ INTERNAL
○ SIP

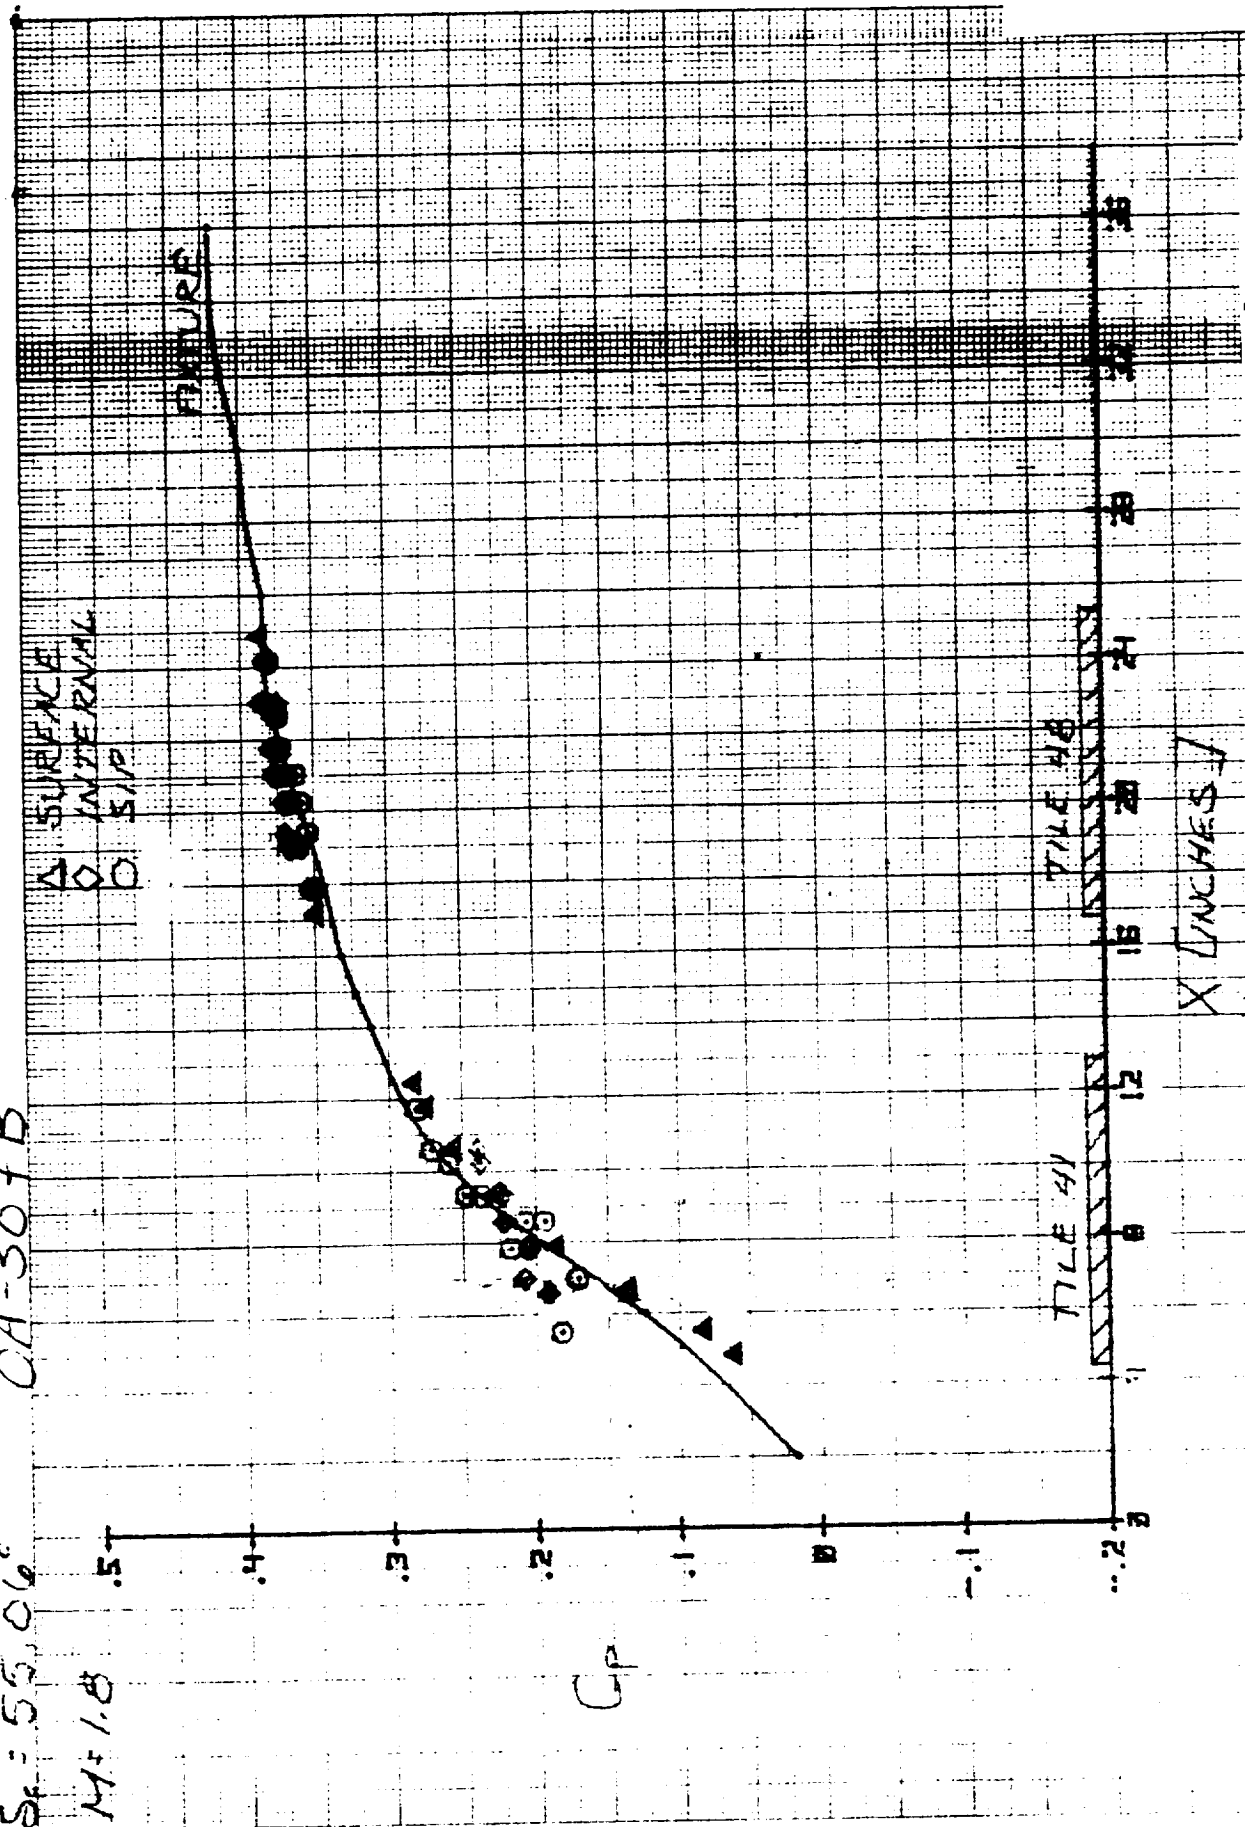
h. Fixture, Tile Surface, Internal and SIP Pressures at $M = 1.8, \delta_F = 55.06^\circ$ - OA307B

△ SURFACE
○ INTERNAL
○ SIP

FIXTURE

TILE 48

TILE 41
